APPLICATION CASE HISTORY

Aggregate Company Learns Value of Loctite® Reliability Training & Loctite® Pipe Repair Kit

Saves \$1,600 in repair costs, avoids wetlands clean-up costs

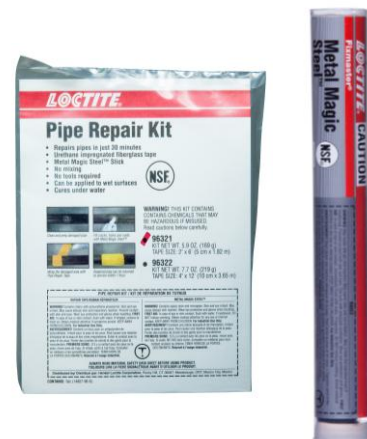
The Company had a 12-inch diameter drainage pipe that had been nicked in two places by a loader during some earth moving. The resulting 3-inch hole left a large leak of sand and slurry water. This was a gravity drain and therefore, no fluid pressure existed in the pipe. Normally, this type of leak would not present a contamination issue. However, it was draining into a designated wetland and was seen as a costly item. If the leak continued, the company would be required to clean up the wetland area by removing the top four inches of soil and replacing the grass.

After Maintenance Workshop on Pipe Repair, the maintenance crew was able to repair the leaky pipe at a cost of about \$60 for the product and \$450 of internal labour costs. The company saved \$1,600 by making the repair themselves rather than hiring the outside pipe repair consultant, and avoided the cost of cleaning up the wetlands area.
